# Service Bulletin No 4/2022

Kanardia d.o.o.  
Lopata 24A  
3000 Celje  
Slovenia

Date: 09.3.2022  
Product: Nesis III A20, Nesis 7, Aetos  
Subject: Black Screen

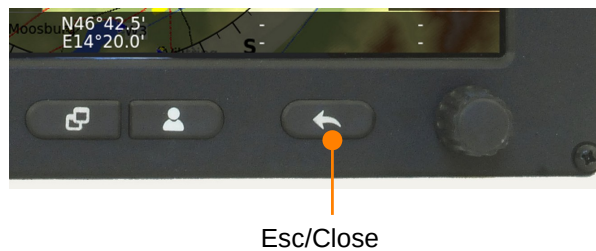
This is the most likely cause of the *black screen* problem. It seems to happen when device was not used for longer period while outside temperatures were low. It looks like the power management system on the A20 module goes into some special state which prevents to power up correctly.

Figure 1: The **Esc/Close** button on Nesis III.

1. Press and hold (long press) the **Esc/Close** button, figure 1. Release the button after about 10 s. This will force the A20 power management chip into reset. If you are able to measure the current consumption of the device, you will notice the current drop from about 60 mA to 30 mA.
2. Press and hold the **Esc/Close** button again for about 5-10 seconds. This will restart the A20 power management in normal mode. You should see device starting to boot. Device shall start working normally.

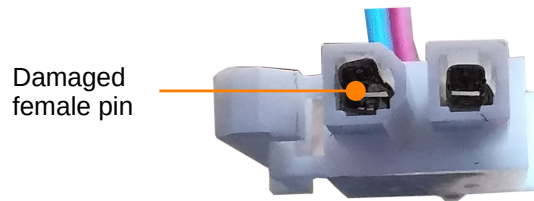
There could be a bad contact on the cable part of connector, which is inserted into Nesis. This is a weak point. The problem is in pins on the cable side (female pins). If the cable is inserted and removed several times, they spread and may cause contact problems. This can also happen after some time

Figure 2: An example of damaged female pin inside the plastic plug.

The correct solution is to replace the connection cable. Please contact Kanardia or one of our representatives and we will send you a new cable.

1. Disconnect the power cable from Nesis.
2. Take pointy tweezers and gently compress together the female pins inside the plastic plug. Alternatively, you may also try to bend the deformed part of the pin back into the shape. Figure 2 shows an example. Do not try to remove the pins from the plastic. Squeeze them inside the plastic plug.
3. Plug the cable back and turn the Nesis on.

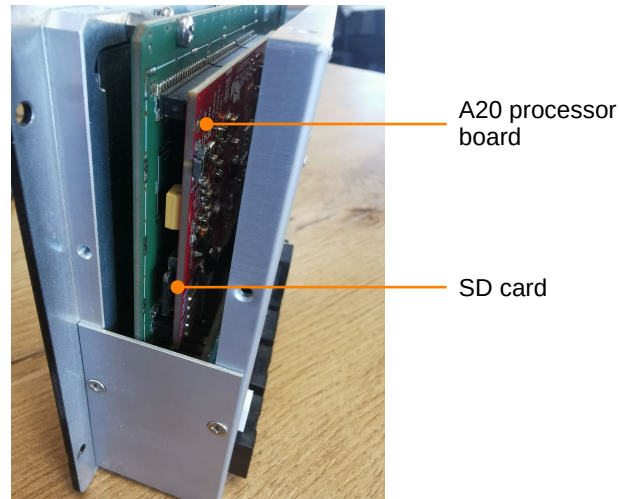
Figure 3: Location of the A20 processor and its SD card in Nesis 7 and Aetos.

3. Locate the A20 processor module and an SD card on the side. See Figure 3.
4. Remove the SD card from the module by gently pushing it inwards. The mechanism will eject the card on release.

5. Take some alcohol and carefully clean the contacts in the SD card.
6. Insert the SD card back. Push it into the slot. The mechanism will lock on release. Put the lid back on.

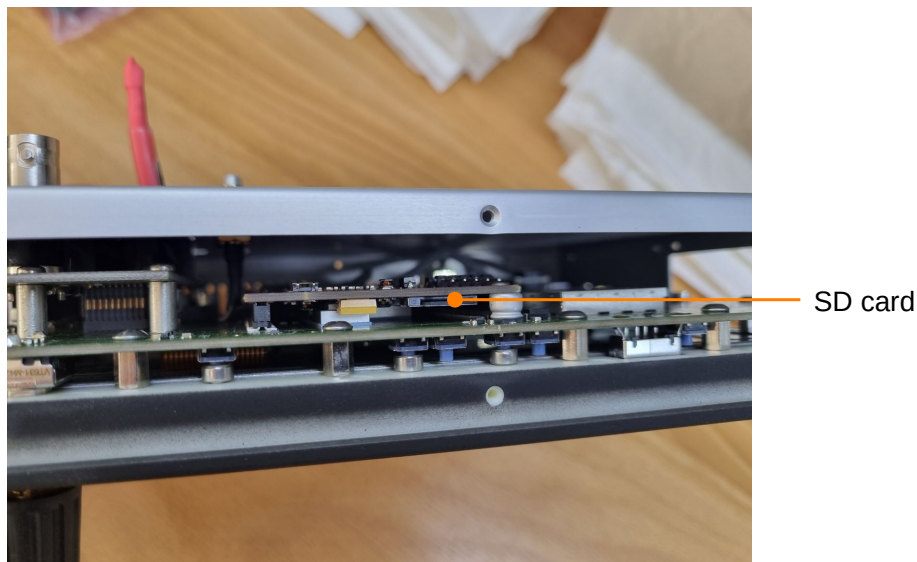
Figure 4: SD card location in Nesis III, A20.

4. Remove the SD card from the module by gently pushing it inwards. The mechanism will eject the card on release.

5. Take some alcohol and carefully clean the contacts in the SD card.
6. Insert the SD card back. Push it into the slot. The mechanism will lock on release. Put the lid back on. Screw-in the inner screws first.
7. Reinstall the instrument back into the instrument panel. Be careful with the pitostatic tubes.
8. Start the instrument. If it starts properly, the problem was solved.
9. If the problem persists, the problem is somewhere else and the instrument must be sent back to us for repair. You can contact [support@kanardia.eu](mailto:support@kanardia.eu) for more information.
