Service Bulletin No 7/2022

Date: 8.11.2022 Product: Daqu 3.0

Subject: Daqu showing wrong RPM value.

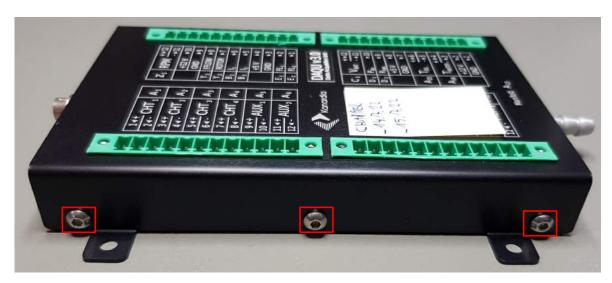
Figure 1: Position of screews, other three are on the opposite side.

1. Remove 6 screws on the side of a Daqu unit and lift the top housing. See Figure 1.

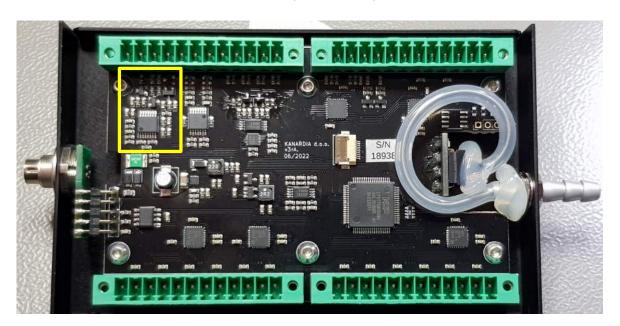
Figure 2: Yellow square shows location we will be working on.

2. Working location is shown in Figure 2 (yellow square), components we will be working on are shown in Figure 3 (red squares).

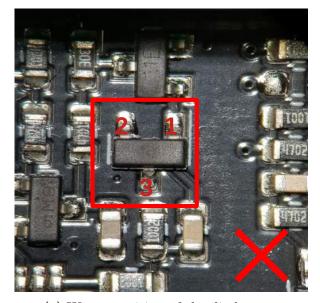
Daqu 3.0 (affected serial numbers in 1. section) has a hardware issue which results in showing wrong RPM value. There is a problem with the diode orientation and resistor position.

(a) Wrong position of the diode.

3. Rotate diode for 180° as shown in Figure 4. Pin 2 is irrelevant and its not soldered.

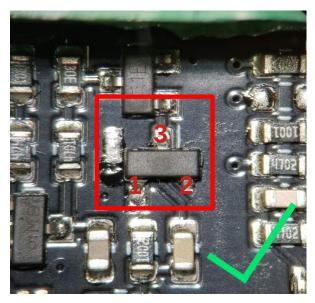
(b) Diode rotated for 180°.

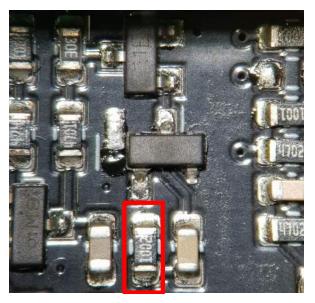
(a) Remove resistor in the red square.

4. Remove the resistor (10k) as shown in Figure 5 and save it for the next step.

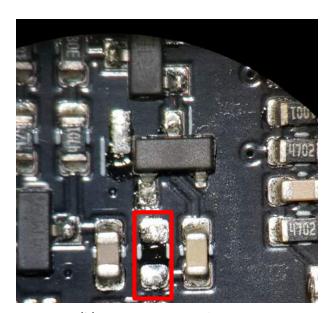
(b) Resistor removed.

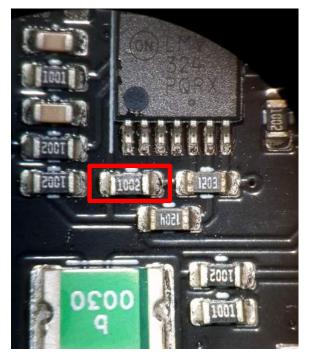
(a) Position where to solder resistor.

5. Solder/stake the previously removed resistor on top the resistor located in the red square as shown in Figure 5. Side view is shown in Figure 7.

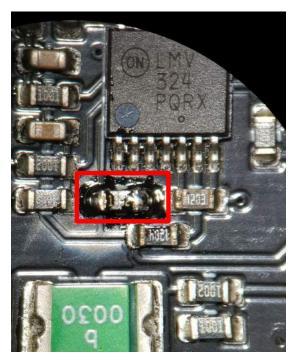
(b) Resistor soldered on top.

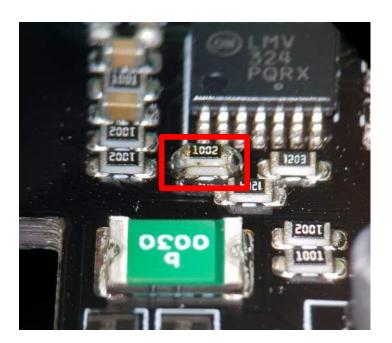
Figure 7: Side view of a staked and soldered resistors.

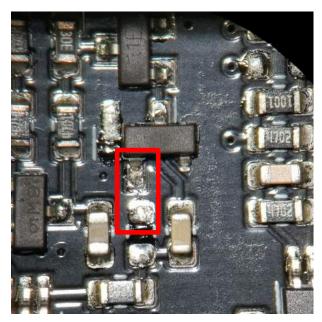
(a) Pads not connected.

6. Connect and solder two pads as shown in Figure 8.

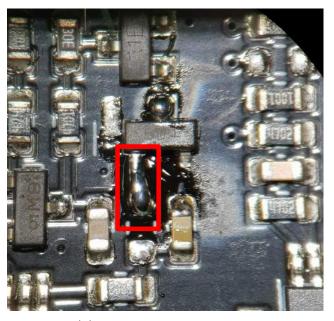
(b) Pads connected.
