Service Bulletin No 8/2022

Date: 14.11.2022
Product: Nesis III
Subject: Sporadic touchscreen issues on Nesis III.

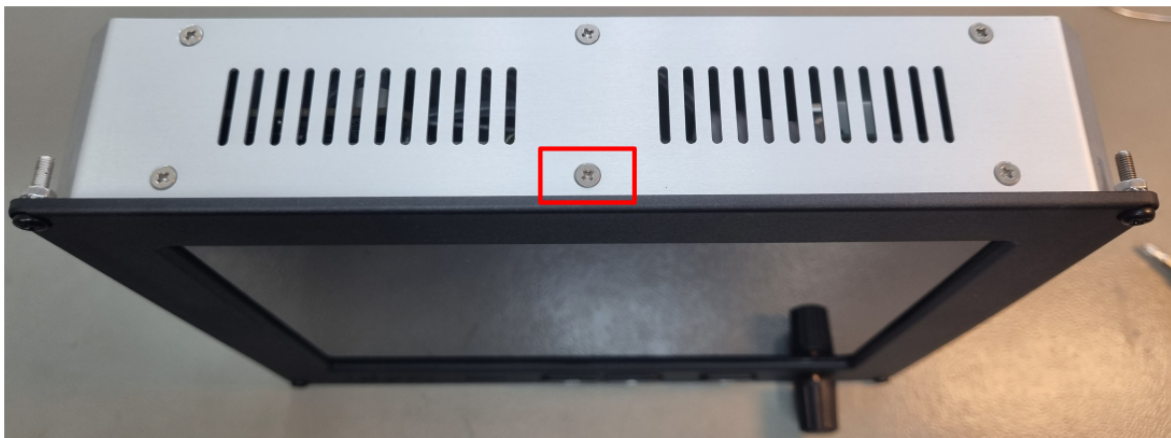
- A tiny metal particle found its way into small gap between the bezel and LCD screen.
- Nesis touch screen and touch screen controller are connected via thin flexible strip. This strip is routed directly beneath one of the screws which connect the bezel and back housing. The screw slightly touches the strip. Vibrations combined with the sharpness of the screw tip cause that isolation protection of the strip is compromised. The leads inside the flexible strip become exposed and in touch with the metal, which in turn may be causing the problems.

Figure 1: Screw to be removed.

1. Remove four screws on the Nesis front bezel which are used to fix Nesis into the instrument panel. Be careful to check how the nuts are fixed at the back.
2. Gently slide/pull Nesis 1 or 2 cm towards you, so that you will be able to access the top screws connecting housing and the bezel, Figure 1.
3. Permanently remove the top middle front screw, which is marked with a red square in Figure 1. Situation after removal is shown in Figure 2.
4. Slide Nesis back and fix bezel back to the instrument panel.

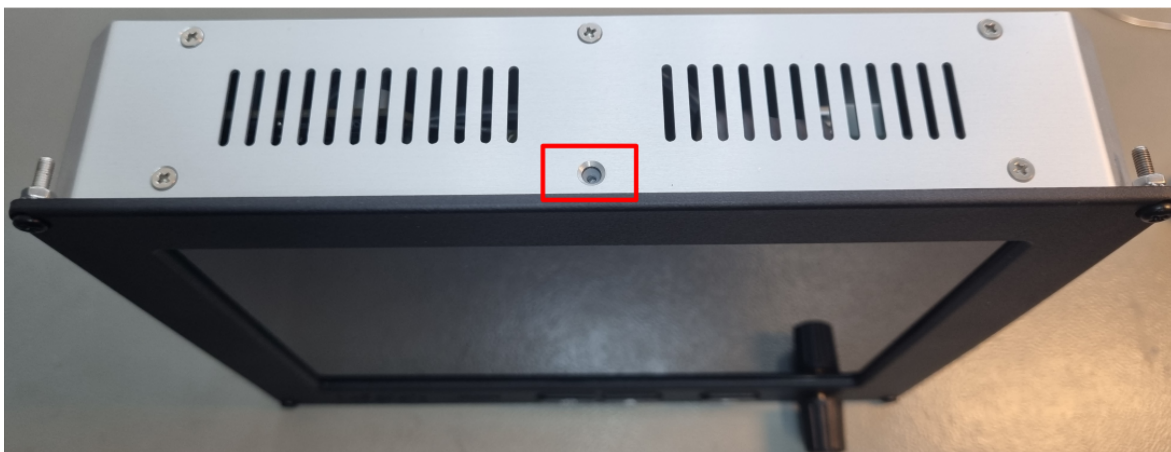
Figure 2: Situation after the screw removal.

Now the screw, which is likely to cause the troubles is removed.
